July 7, 2023

RE: 8505 State Bridge Road
Tree Assessment

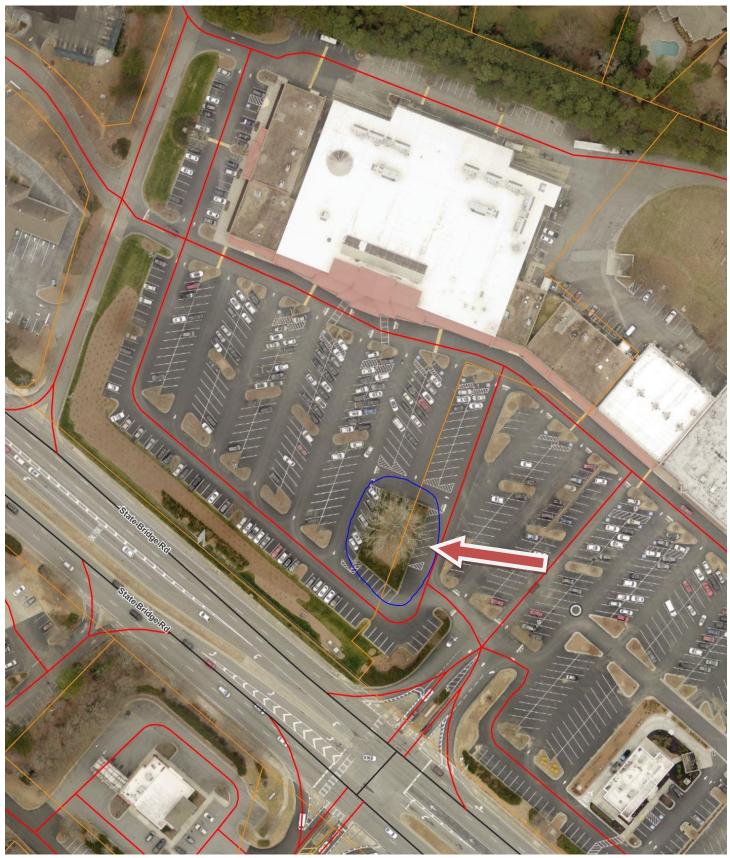
Location of assessed 50" Water Oak tree

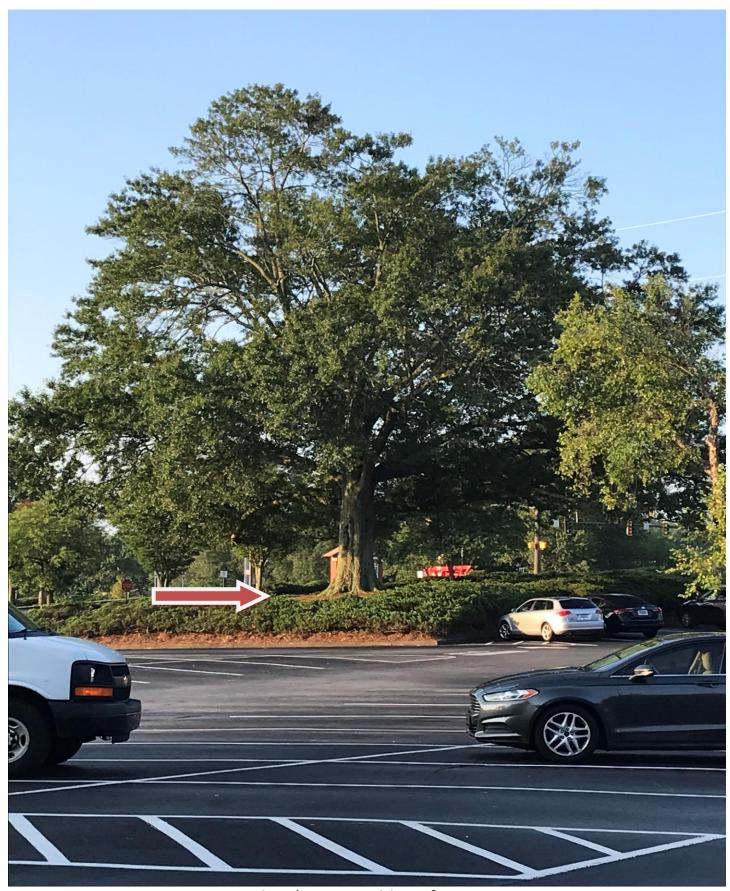
- The tree is located in an island that is elevated approximately 5' from the grade of an existing parking lot
- There is sufficient soil volume to support the root system of the tree

Landscape position of tree

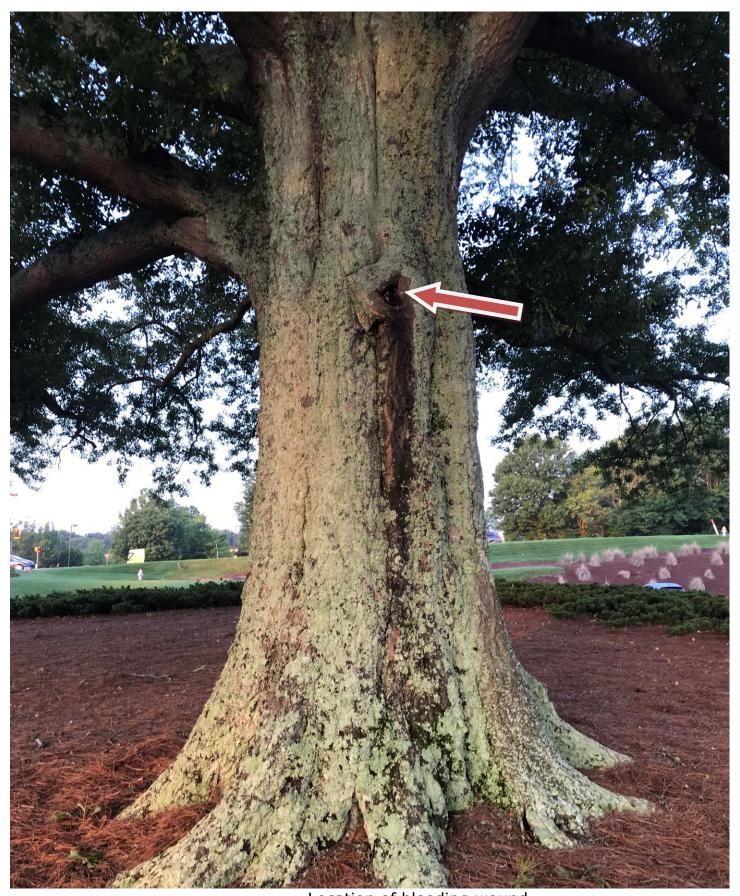
- There is one small old pruning wound on the northeast side of the tree at approximately 10' that has been weeping fluid
- There are multiple low overextended limbs with weak stem attachments

Location of bleeding wound 8505 State Bridge Road Tree Assessment by Arborguard, 7/7/2023

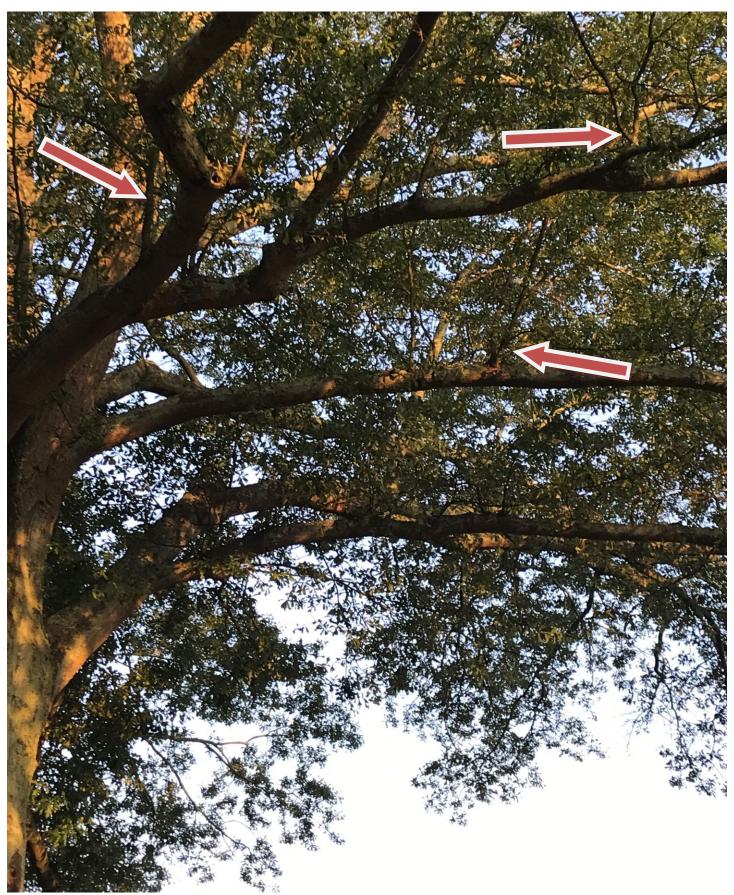
The numerous epicormic sprouts (vertical small branches emanating from main tree branches) are an indicator that the tree is experiencing some type of stress often seen in trees during the initial stages of decline.

Examples of significant epicormic sprouting 8505 State Bridge Road Tree Assessment by Arborguard, 7/7/2023

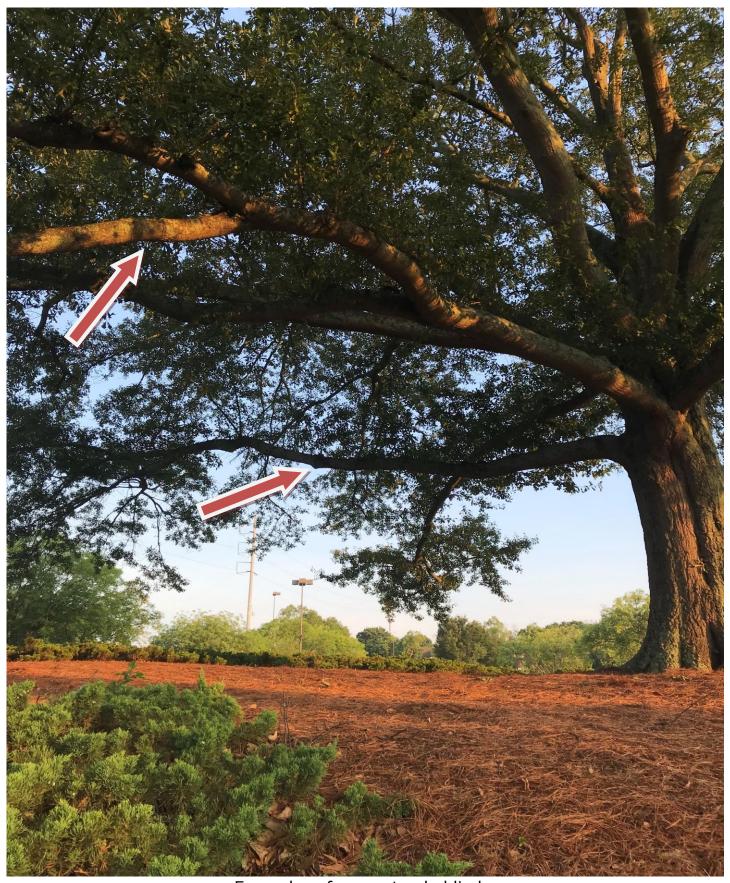
There are multiple low limbs that are overextended and are bearing a significant amount of foliar end weight. The typical failure mechanism of a mature hardwood tree is to start shedding these large, overextended limbs. The process is called retrenchment and is a common survival strategy intended to prolong its life.

Examples of overextended limbs

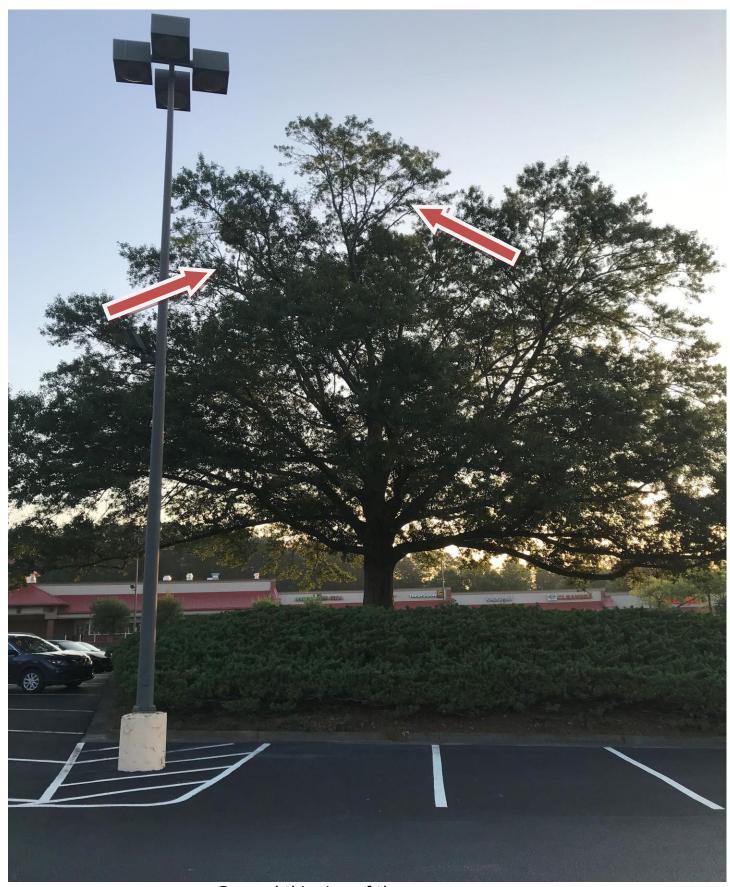
This tree is currently exhibiting signs of decline in the upper canopy signified by two areas of obvious decline located on the northeast and southwest sides of the tree and a general slight thinning of foliage in the upper canopy. The lower portions of the tree canopy appear to be healthy.

General thinning of the upper canopy

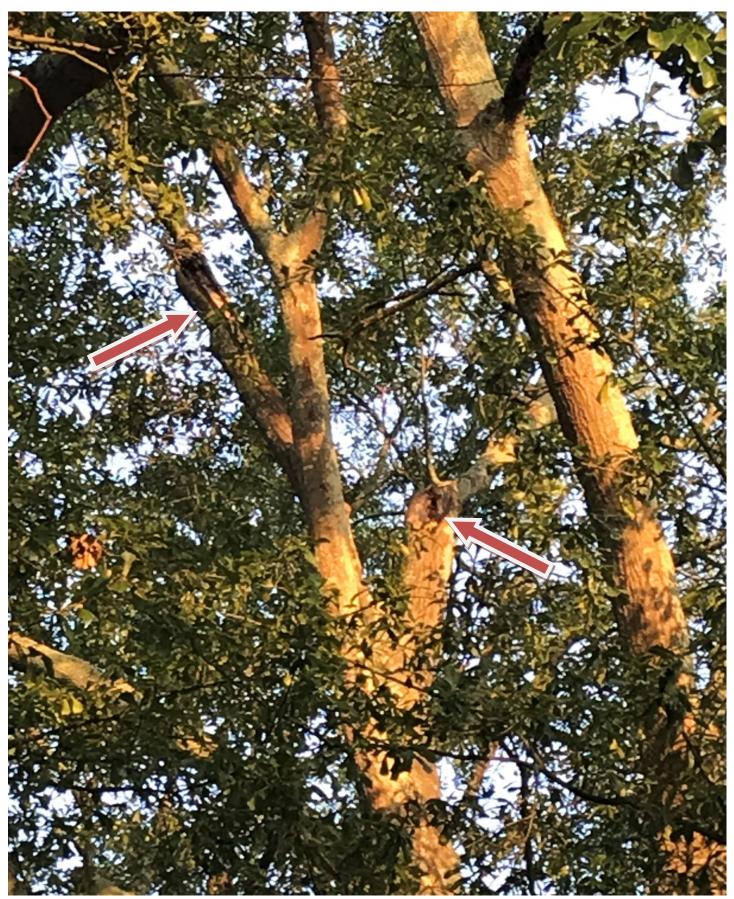
There are two stems in the upper tree canopy that have obvious areas of decay, these stems will likely fail at some point within the next couple of years.

Two stems in upper canopy with decay 8505 State Bridge Road Tree Assessment by Arborguard, 7/7/2023
