Turning Performance Analysis

Bid Number: Johns Creek Fire Department

Chassis: Velocity Chassis (Big Block) Pumper, Long, Alum, 2nd Gen **Body:**

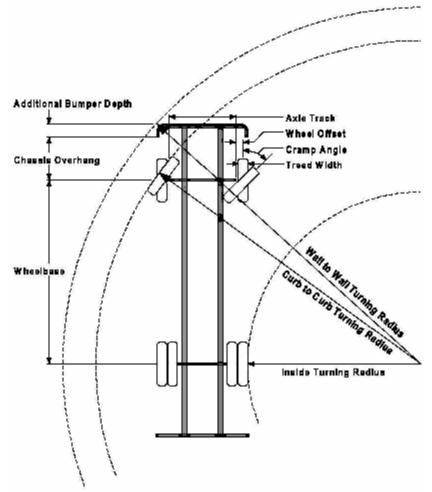
Inside Cramp Angle:	45°
Axle Track:	82.92 in.
Wheel Offset:	4.68 in.
Tread Width:	17.70 in
Chassis Overhang:	78.00 in
Additional Bumper Depth:	0.00 in
Front Overhang:	78.00 in
Wheelbase:	194.00 in.

Inside Turn:	15 ft.	0 in.
Curb to Curb:	29 ft.	4 in.
Wall to Wall:	33 ft.	2 in.

Inside Cramp Angle Maximum turning angle of the front inside tire.

Axle Track King-pin to king-pin distance of the front axle.

Wheel Offset Offset from the center-line of the wheel to the king-pin.

Tread Width Width of the tire tread.

Inside Turning Radius Radius of the smallest circle around which the vehicle can turn.
